Debris/Ice/TPS Assessment And Photographic Analysis For Shuttle Mission STS-36

April 1990

DEBRIS/ICE/TPS ASSESSMENT
AND
PHOTOGRAPHIC ANALYSIS
OF
SHUTTLE MISSION STS-36

February 28, 1990

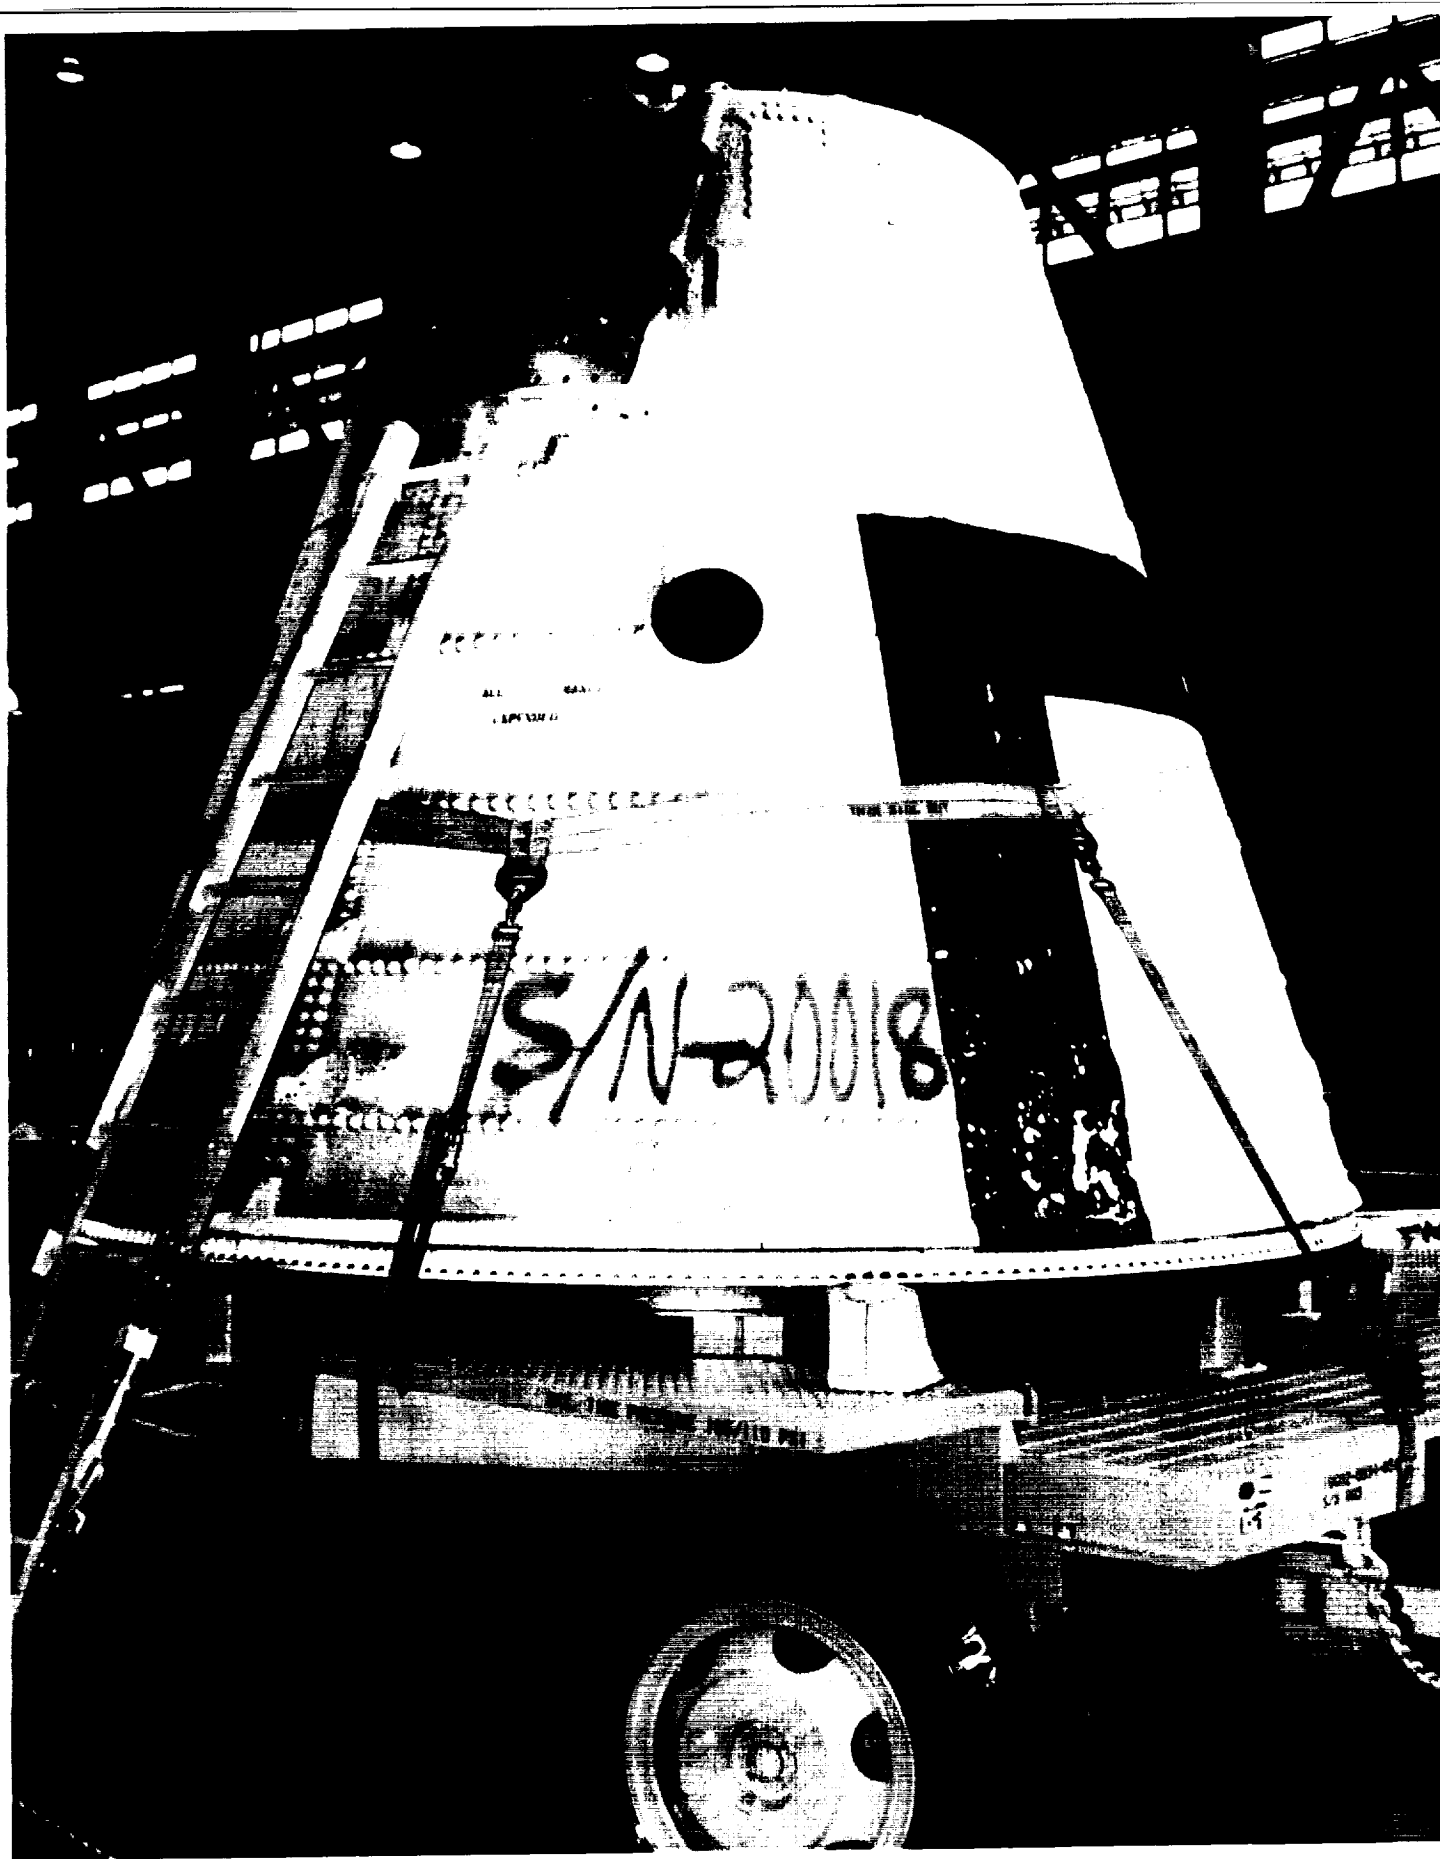
Overall view of LH frustum with localized areas of Hypalon paint blistering in the visibility stripes

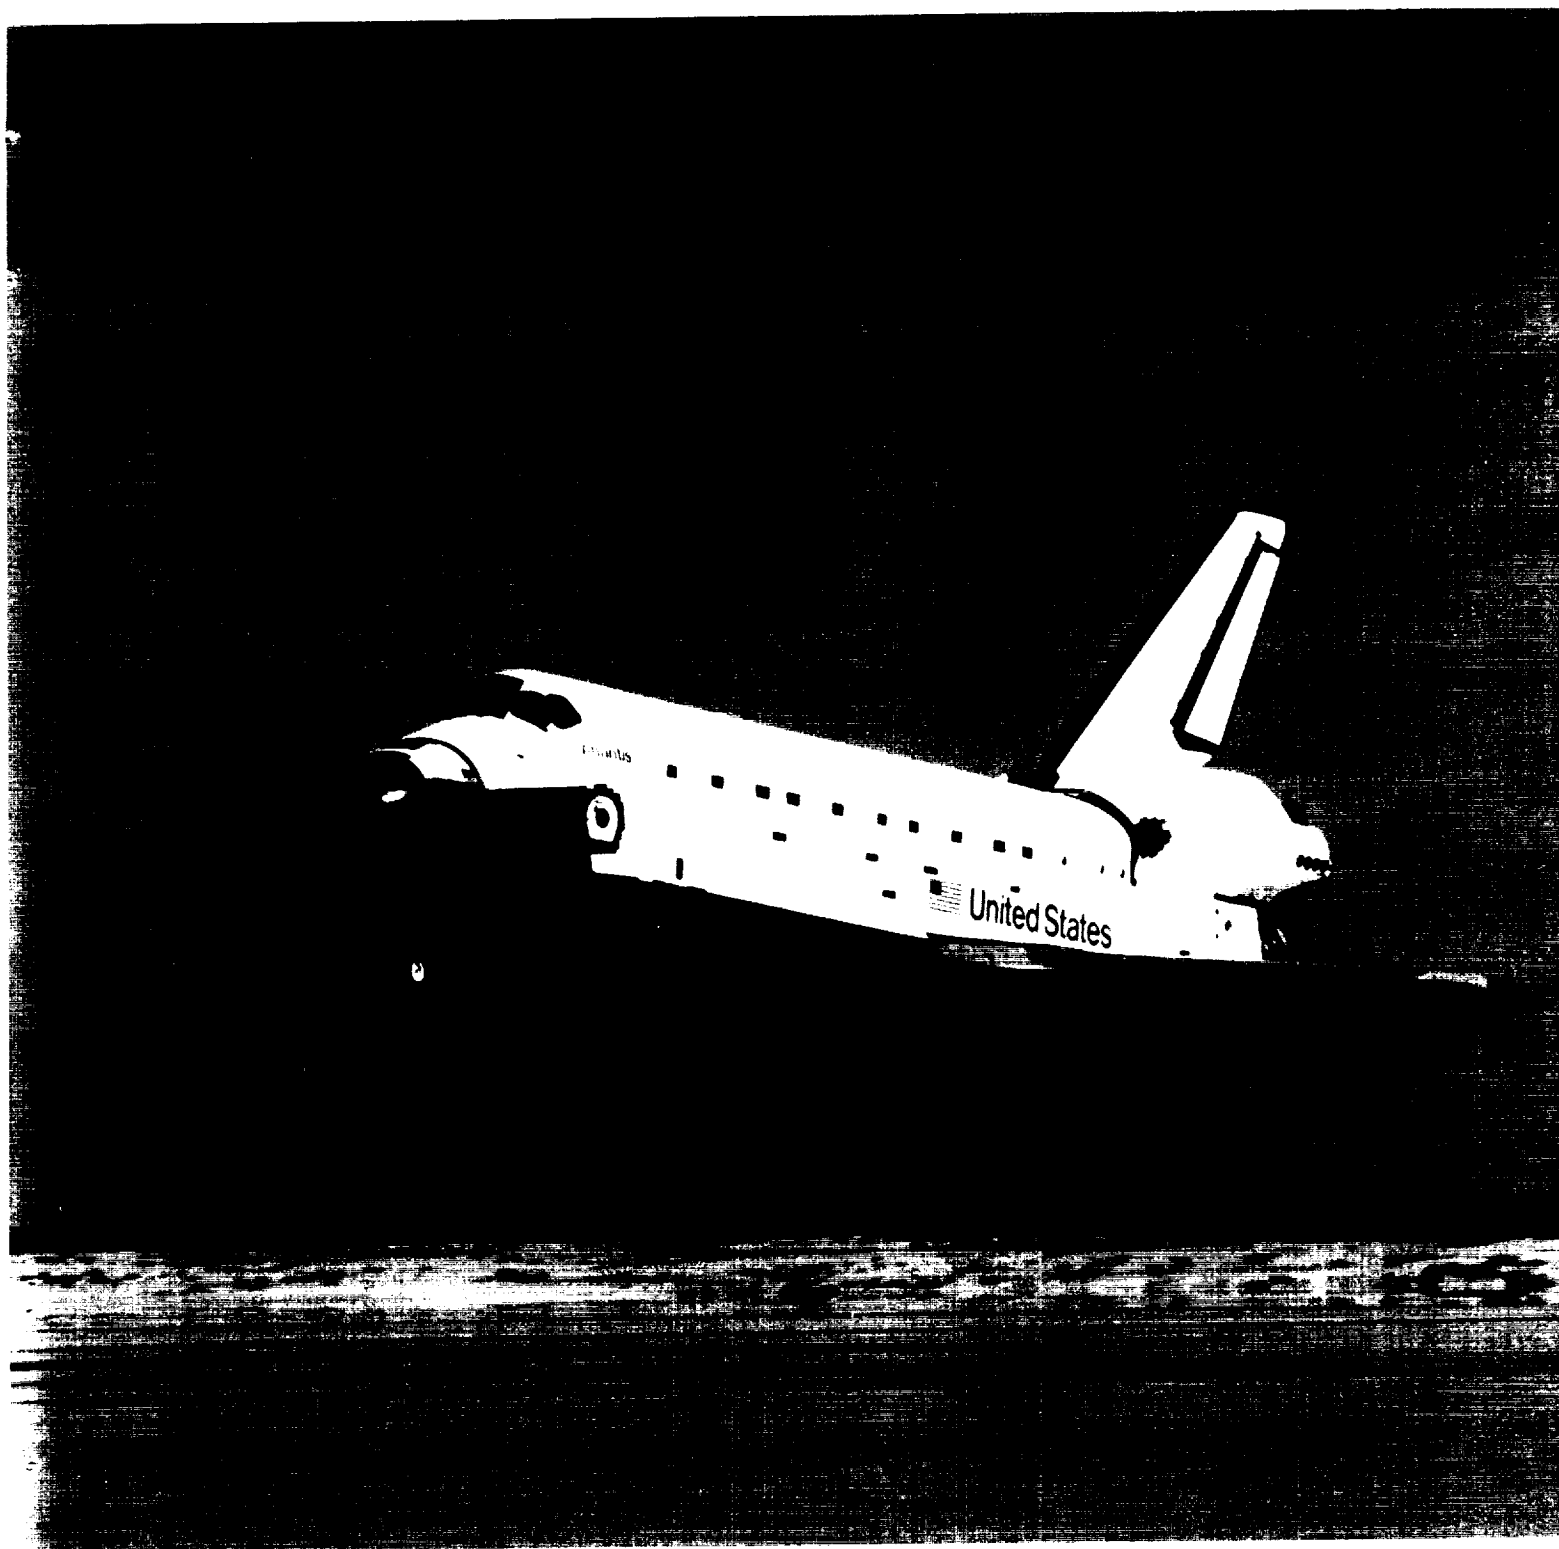
No major TPS damage was visible on OV-104 Atlantis just prior
to touchdown at Ames-Dryden/Edwards AFB

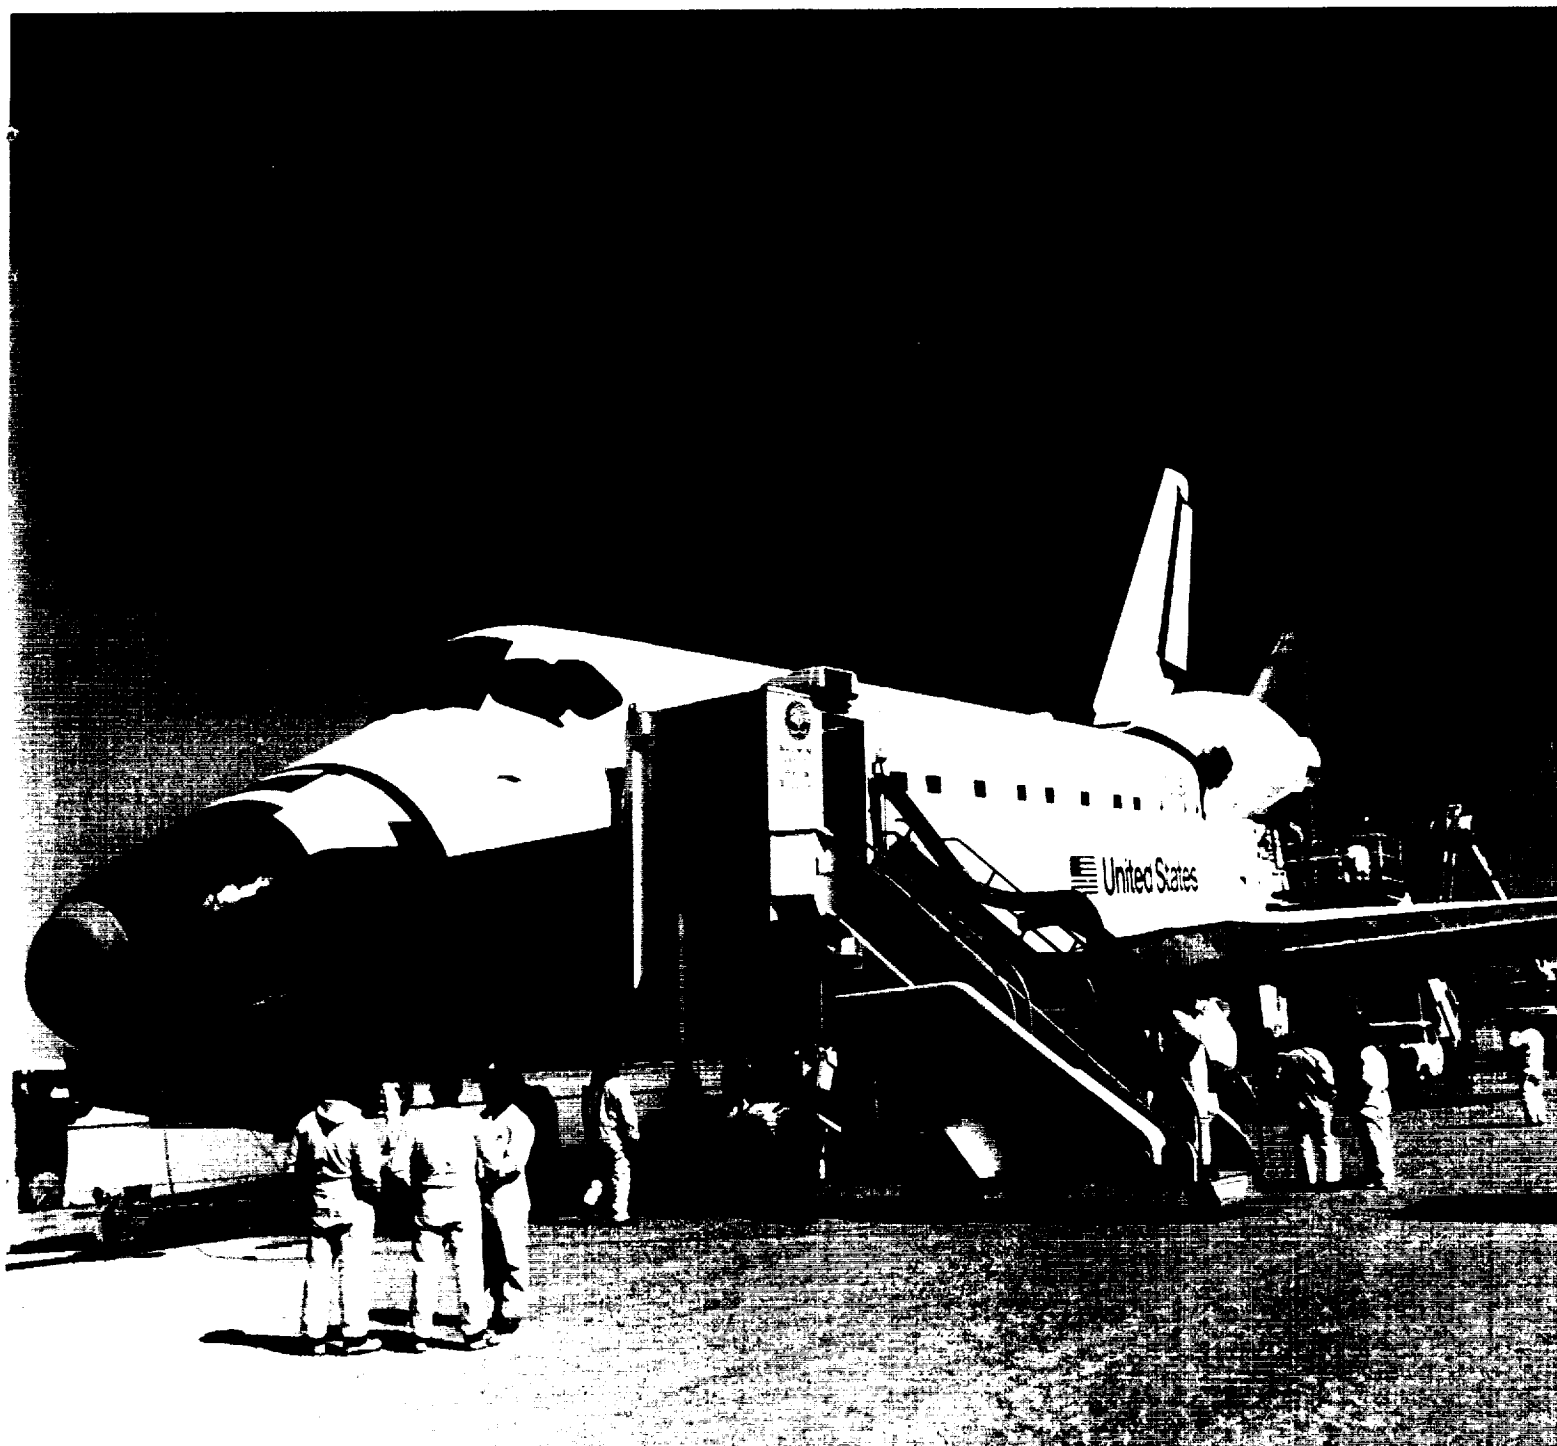
Overall view of OV-104 LH side after landing

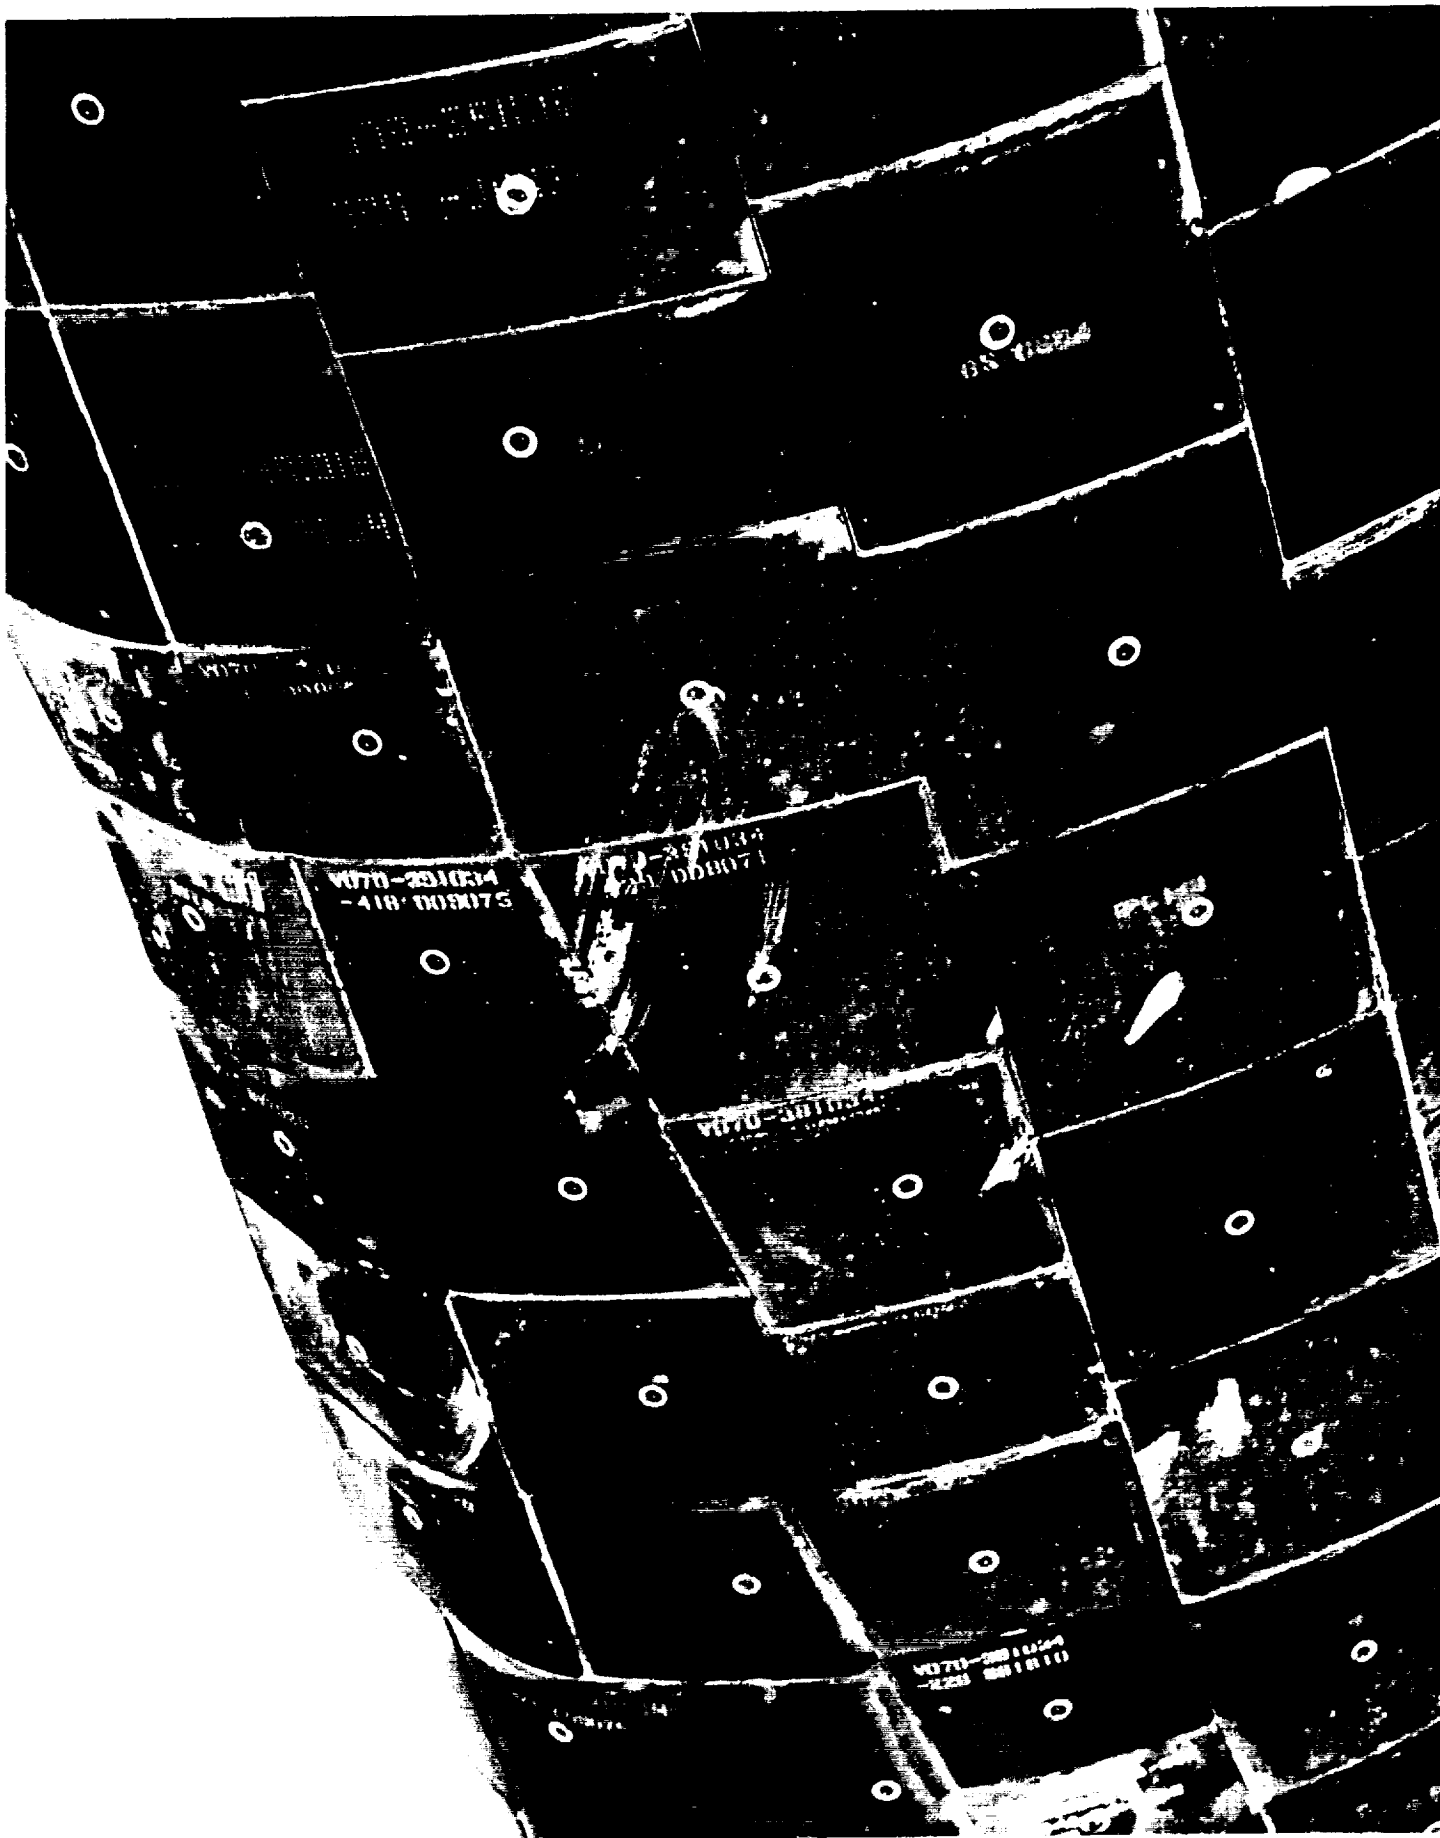
White residue was present on LH chine lower surface tiles

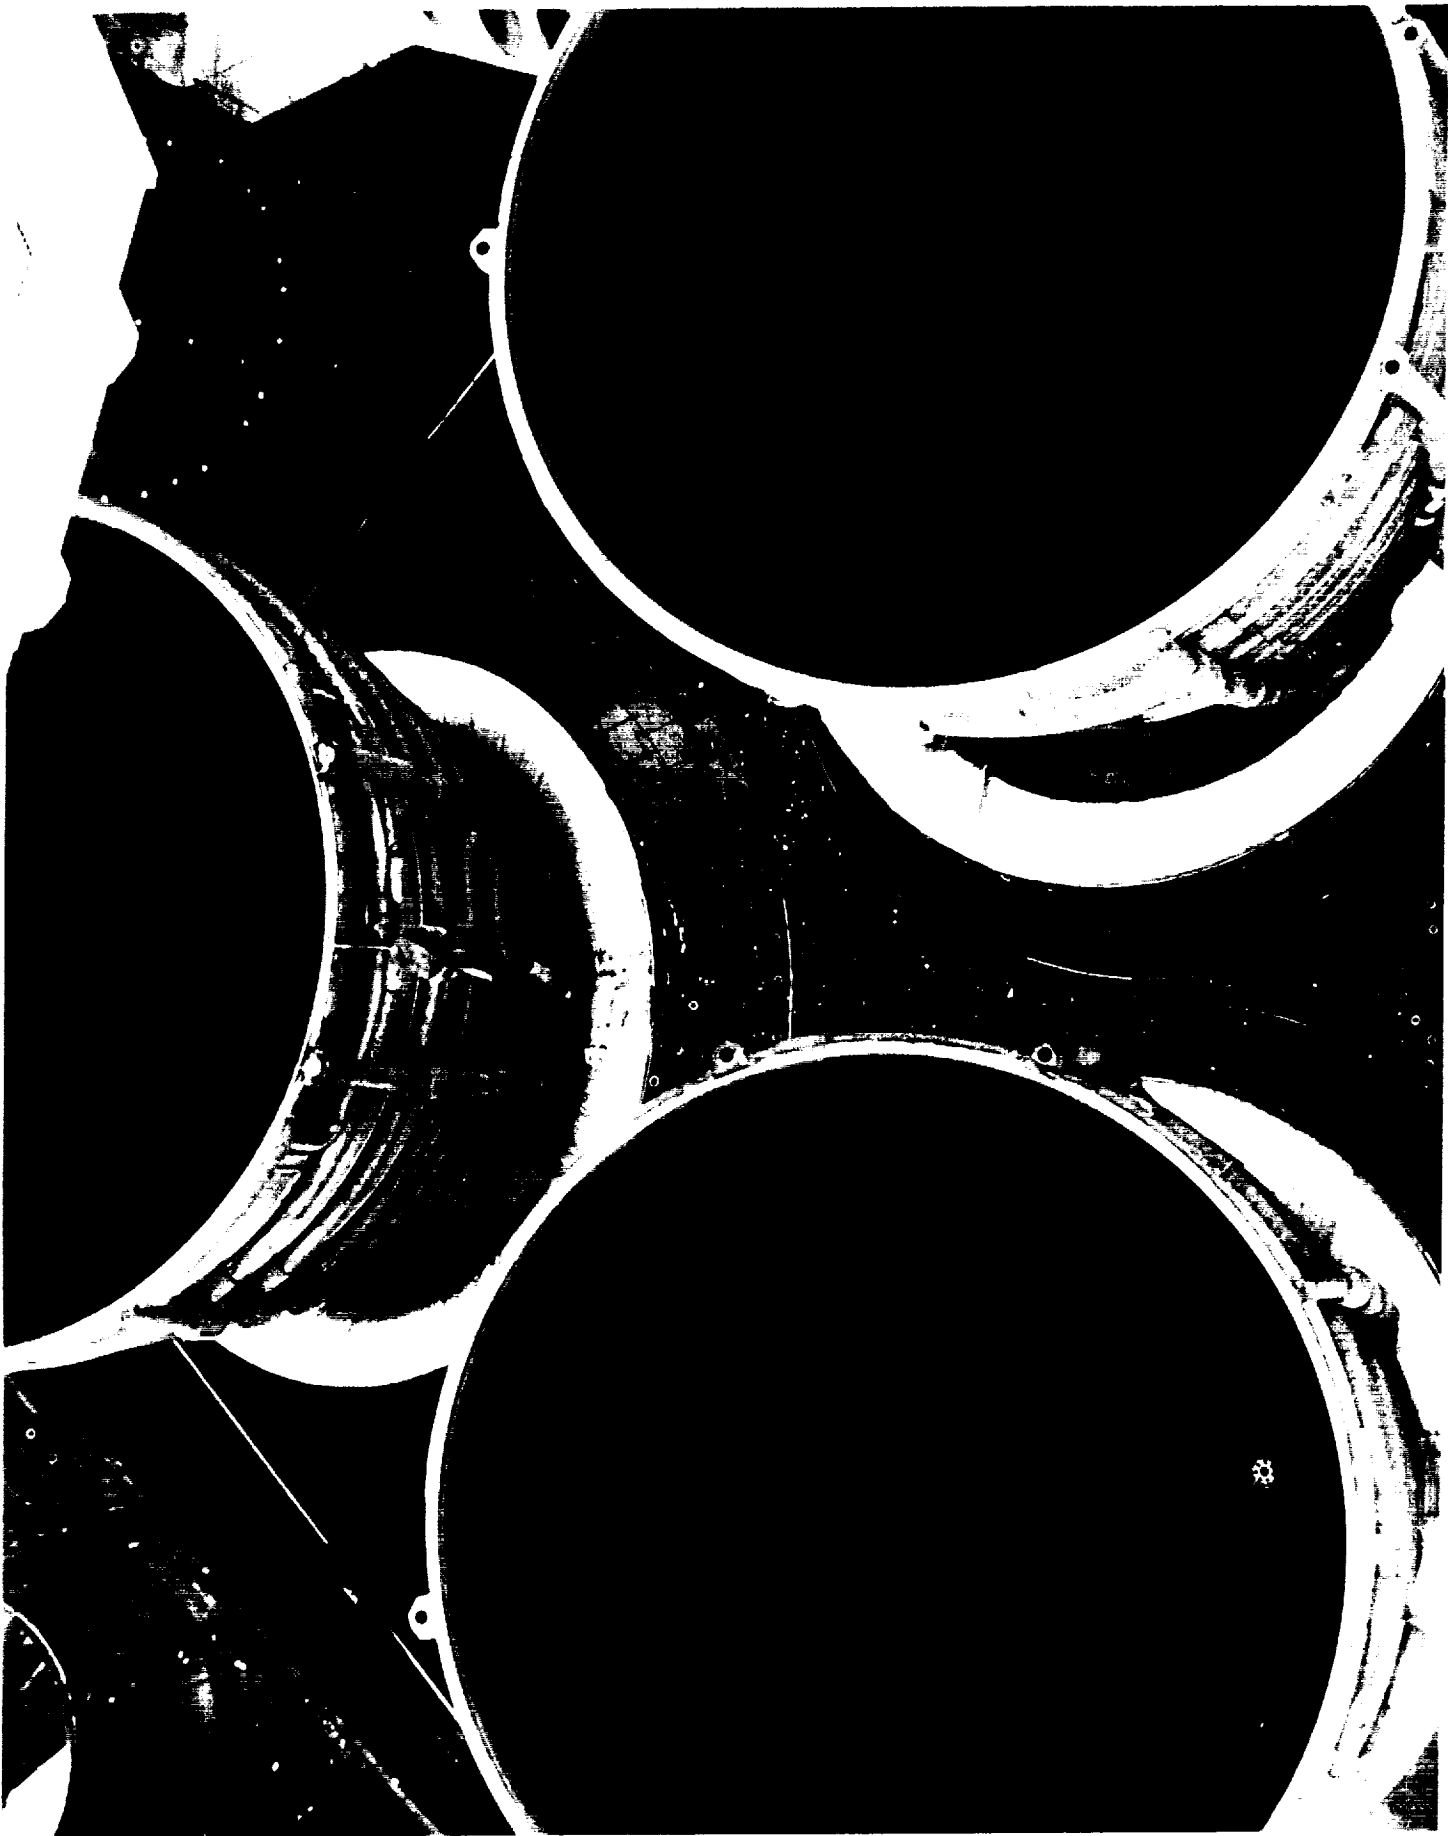
200

Overall view of SSME's and Orbiter base heat shield area
after landing

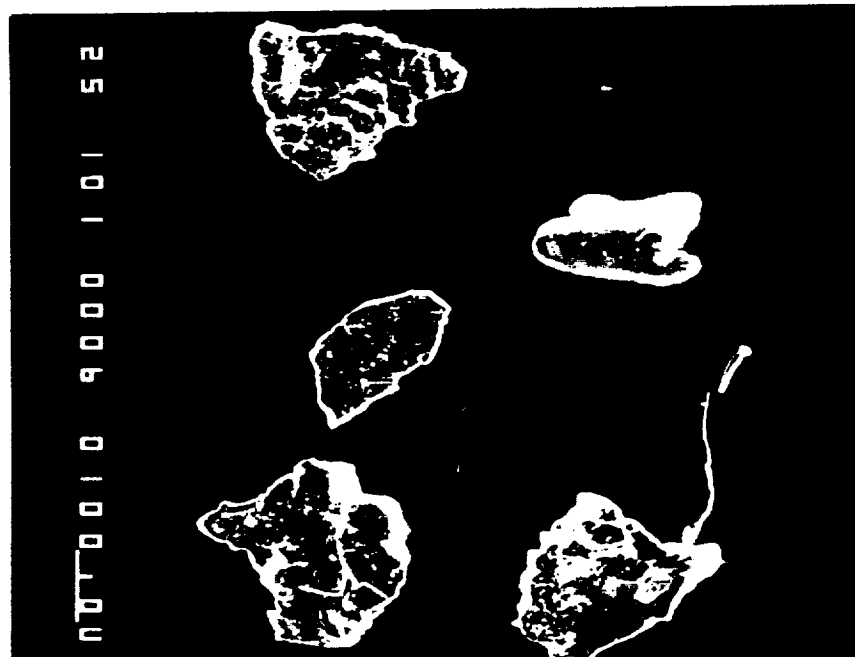
2.2.4 Figures 3 and 4 are low magnification SEM photomicrographs of black and white tiles to show the morphological features of these materials.

Figure 4. Low magnification SEM photomicrograph of white tile materials. 66X
